# Transitions: How to Design Facade Interfaces

By Karol Kazmierczak and  
Dan Neeb, Halliwell Engineering Associates

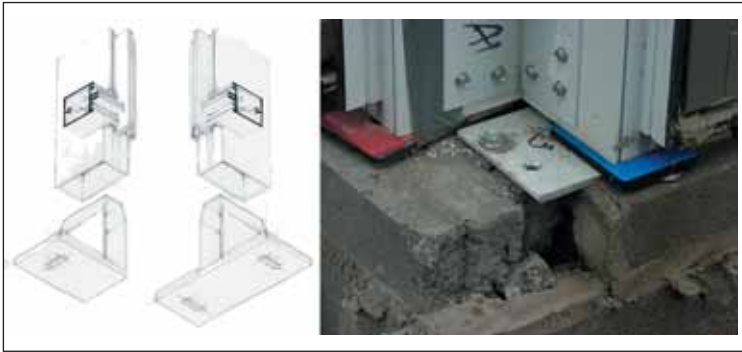
Figure 8. Examples of transom discontinuity.

air barrier, sealed to the non-continuous bottom transom. This error is particularly evident at the corners of a curtain wall. This is also a potential problem when a designer decides to use a transom different than a mullion, either for economy or aesthetics—see **Figure 8** showing a corner of a curtain wall sill.

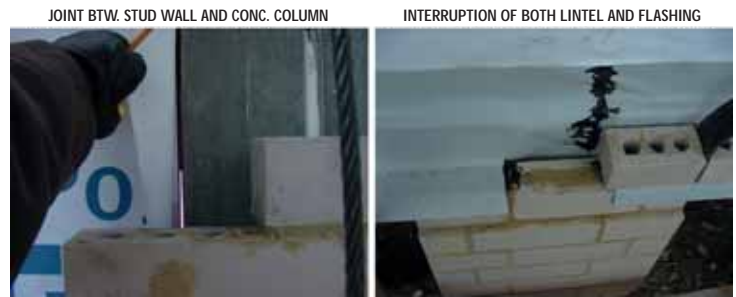
Figure 13.

The photos in **Figure 13** were taken when the brick veneer was already being erected, after the substrate had been accepted by the masons. The joints around wall panels remained unsealed; an observer can see through the crack. Moisture problems are likely to develop due to the condensation induced by an unpredictable pattern of air leakage and discontinuity of the drainage plane. The mechanical system may negatively pressurize the interior walls and suck the humid outside air inside in summer; a positive pressure in the apartments would blow the moist interior air to the outside in winter. The interruptions of both the lintel and the thru-wall flashing ensure chimney effect in the wall

cavity. A transfer of insects, odors and sound among apartments through the open cavity are among probable side effects.

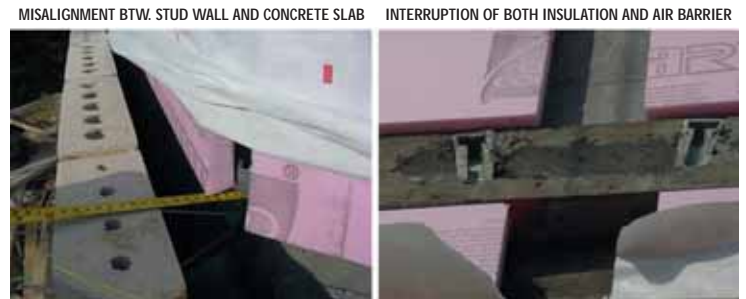
Figure 14.

The photos in **Figure 14** show the misalignment between the face of insulating sheathing and concrete. The tape reads over 2 in. (5 cm). In the above drawings, construction tolerances, particularly the cast-in place concrete tolerance is not anticipated. The air barrier was installed in a discontinuous fashion which creates problems.
